Miscellaneous Paper SL-98-1
January 1998

Investigation of Concrete from I-20 Near Monroe, Louisiana

by G. Sam Wong

Final report

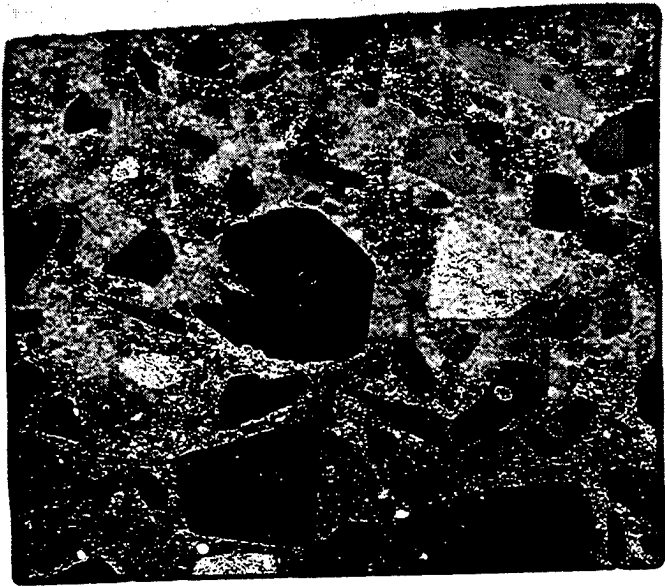
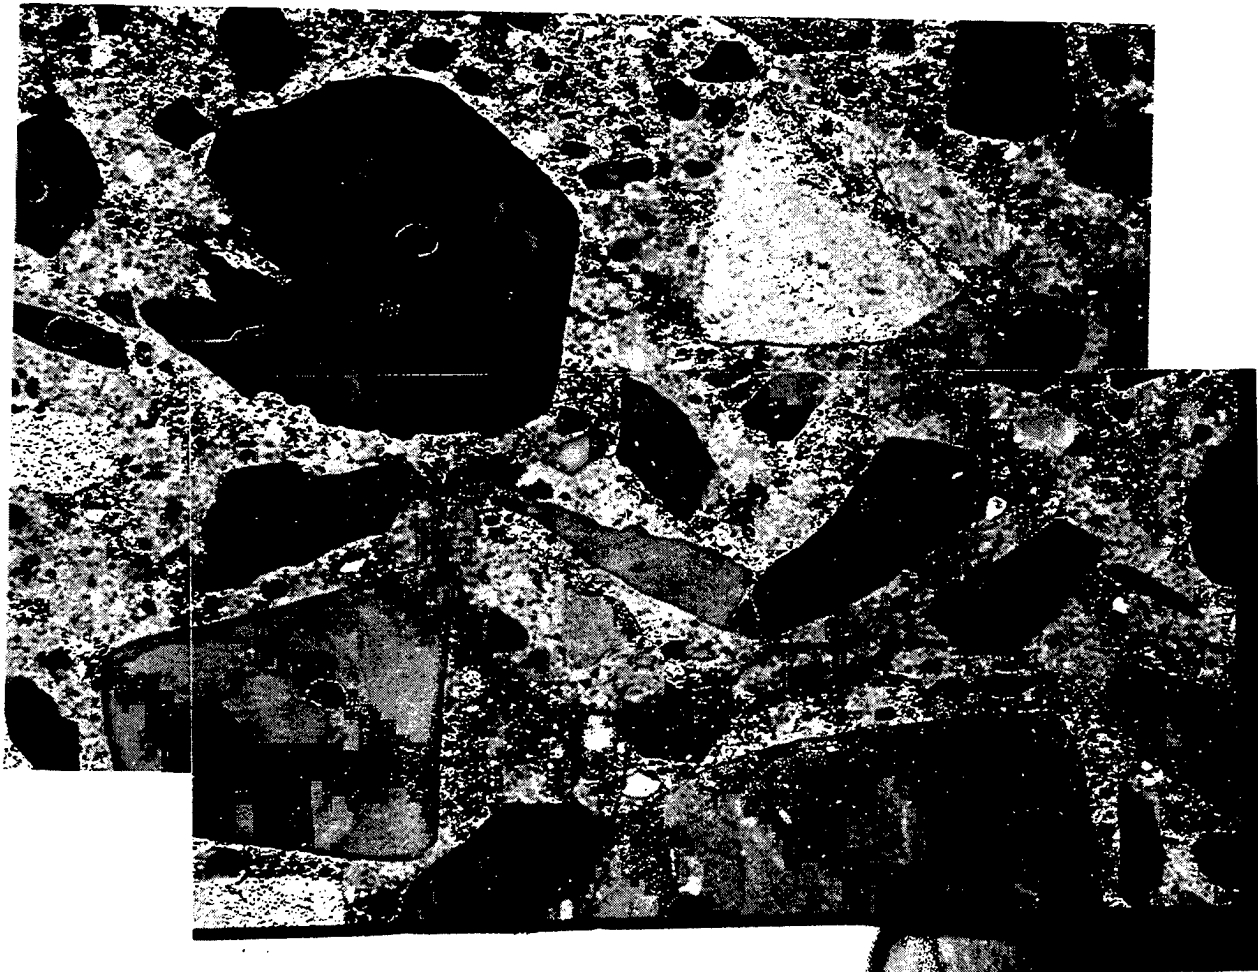
- l.* 950618 - This concrete was heavily cracked. Vertical, horizontal, and diagonal cracks were abundant throughout the length of core. The cracking was associated with a large dark-gray limestone coarse-aggregate particle (Figure A11, Appendix A). Fractures were observed in the central portion of the aggregate particle as well as in the rim area of the particle. A specimen of this aggregate particle was cored along the paste-to-aggregate interface and prepared for examination as a ground section. The specimen was impregnated using an epoxy resin to reinforce the sample and minimize possible additional cracking in the preparation process. The specimen showed the propagation of cracks through the interface zone. The cracks were not confined to the interface zone of the aggregate particle as they propagated into the interior of the aggregate particle. The interior portion of the aggregate particle was also cracked. High-resolution elemental analysis using the scanning electron microscope (SEM) and energy dispersive X-ray (EDX) showed no migration of elements in this particular aggregate particle, as illustrated in Figure 27.

Figure A11. Sample 950618 shows random crack pattern with cracks propagating from central reactive coarse-aggregate particle. Other reactive particles are also evident. Top sample is 6 in. (152 mm) left to right

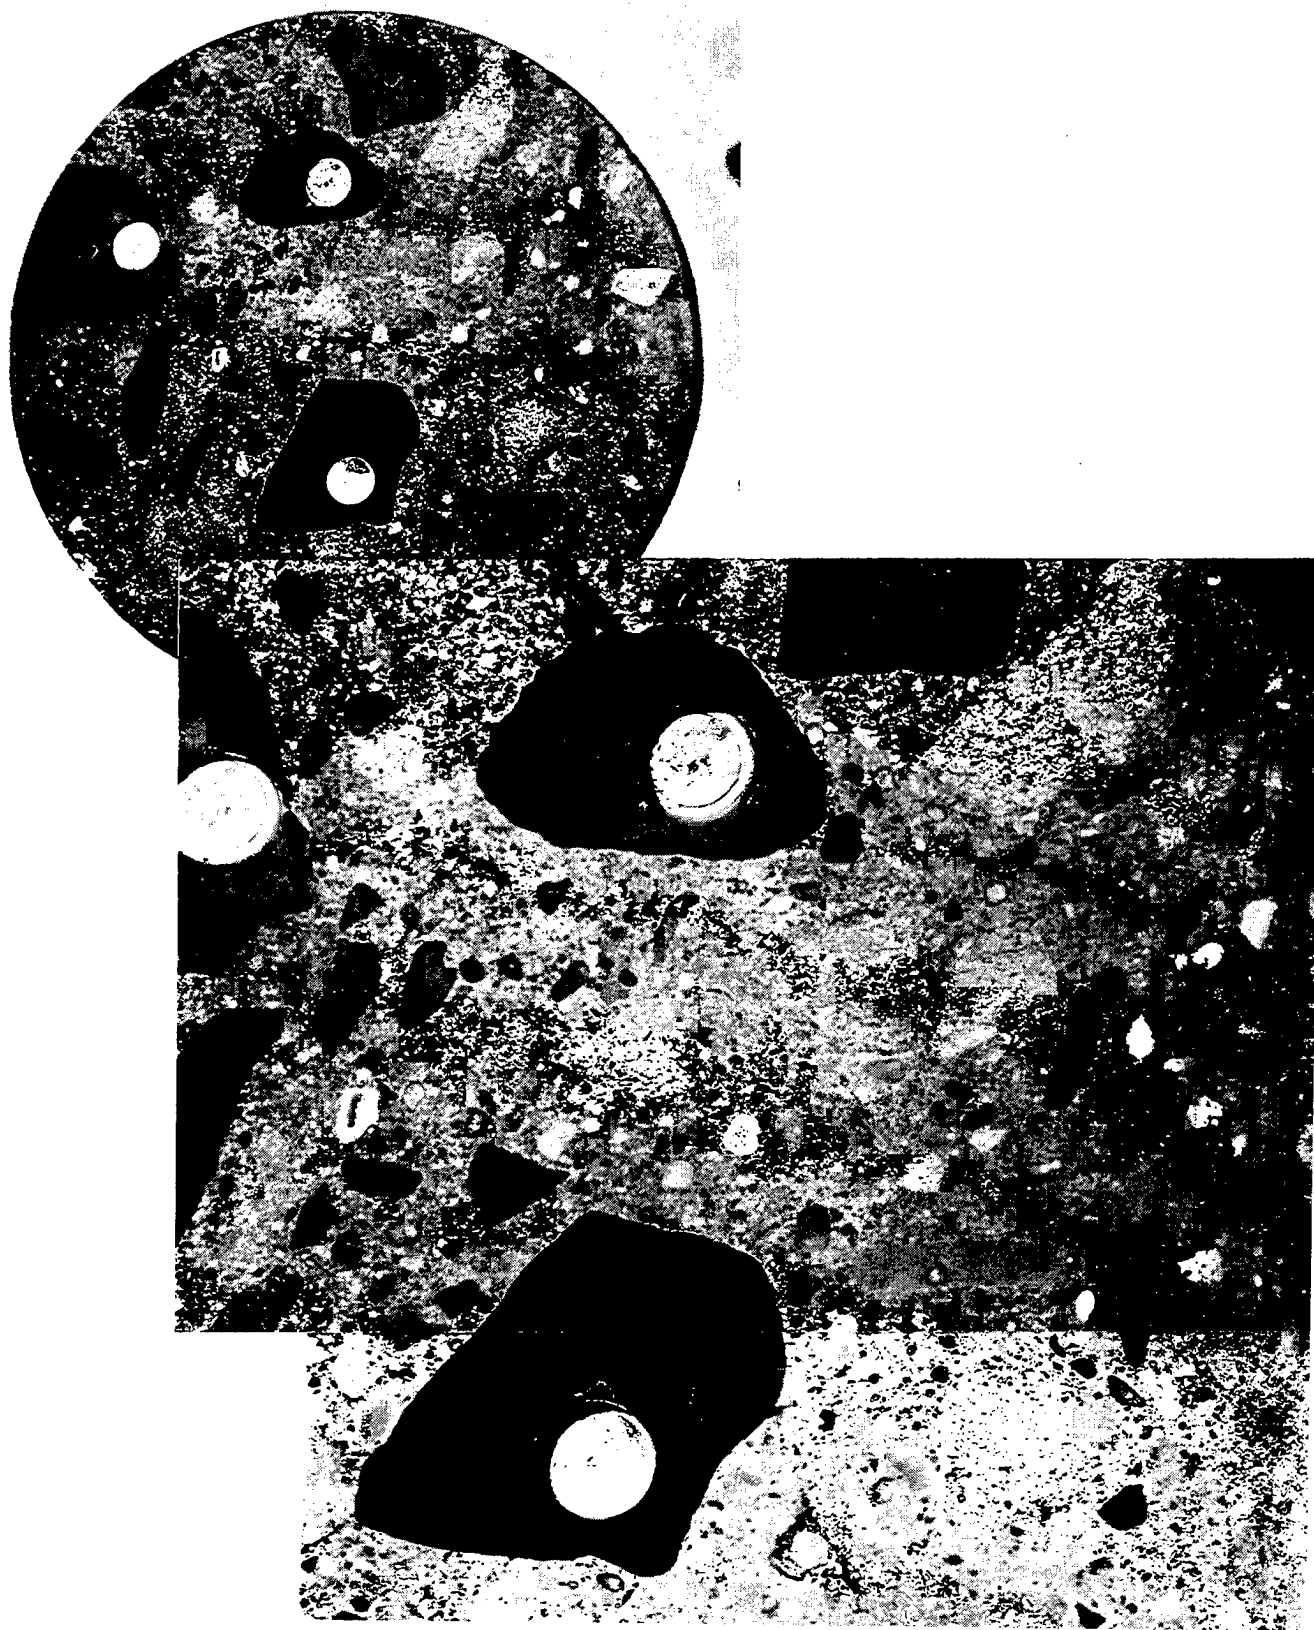
- m.* 950621 - This concrete had some hairline cracks at the surface. One crack penetrated into the interior concrete approximately 1 in. (25.4 mm) and terminated in the paste. The upper portion of the concrete consisted of lighter colored limestone coarse-aggregate particles. The lower portion of the core contained numerous dark-limestone coarse-aggregate particles with dark reaction rims. Some cracks associated with these limestone aggregate particles are shown in Figure A12, Appendix A. The X-ray diffraction pattern of aggregate particle #A, a dark-gray particle with a prominent dark reaction rim, showed it to be pure limestone, as shown in Figure 23. Light-colored brownish limestone with a reaction rim (particle #B) was pure limestone, as identified in Figure 24. The dark-gray particle

with a prominent reaction rim (Figure A12, Appendix A) (particle #C) was a fine-grained dolomitic limestone also containing insoluble material including clays and quartz (Figure 25). A thin section of a near-surface dark-gray fine-grained impure limestone coarse-aggregate particle showed a rim on this aggregate and micro cracks in the rim propagating into the paste. Etching of coarse-aggregate particle using dilute hydrochloric acid showed no relief in the rim area; i.e., the rim was neither more nor less acid soluble than the unaltered rock.

Figure A12. Sample 960621 shows aggregate particles A, B, and C. A is non-expansive, B is non-expansive, and C is expansive. Top sample is 6 in. (152 mm) left to right

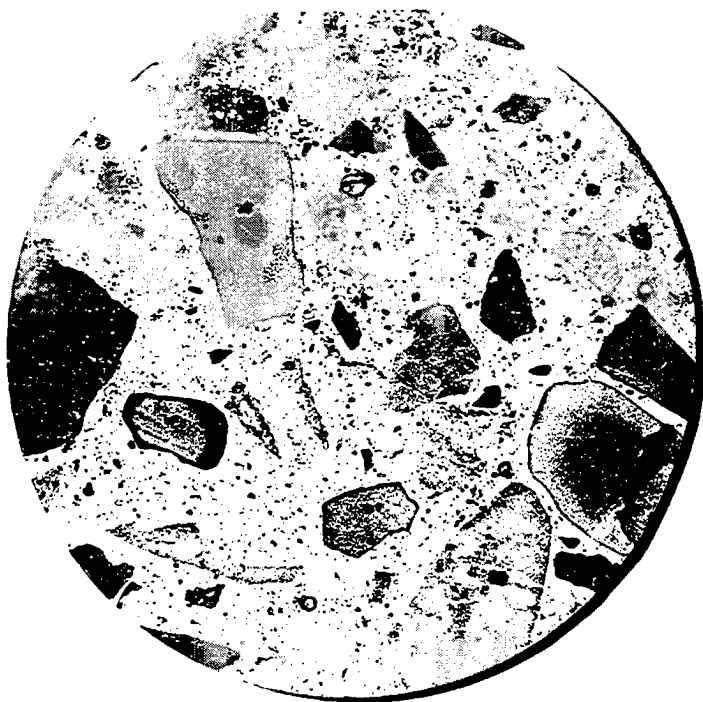
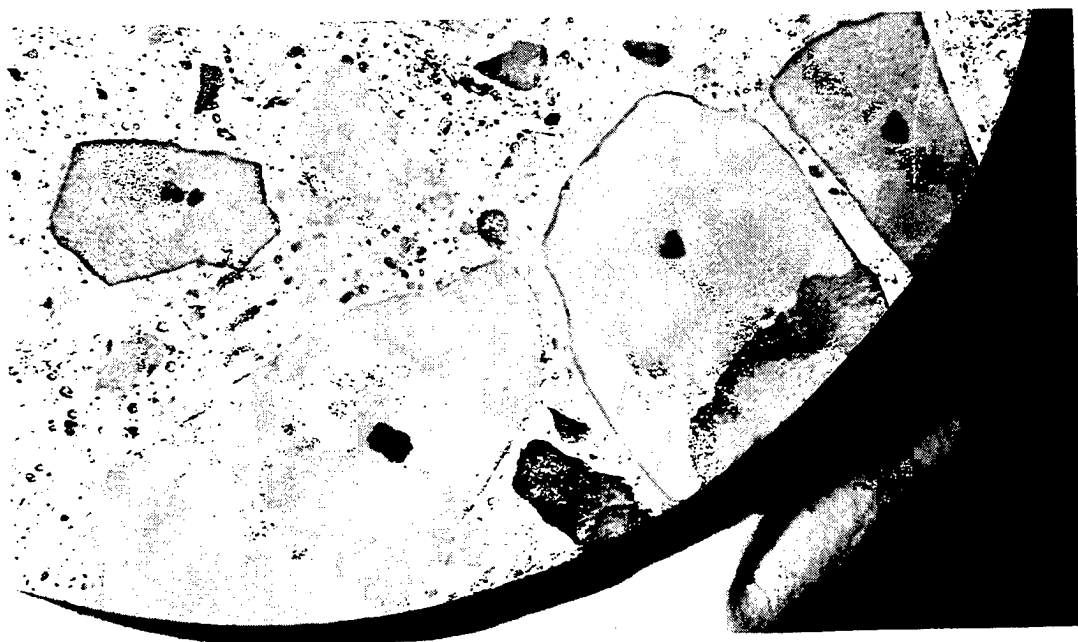
Figure A13. Sample 950615 shows some non-expansive reactive aggregate particles. Top sample is 6 in. (152 mm) left to right
